AIRCRAFT HYDROGEN LEAK DETECTION SOLUTION

**Hydrogen Showcase**

20 September 2022
Aerospace Integration
Research Centre (AIRC),
Cranfield campus

Nitto DX-2106H Hydrogen Detection Tape

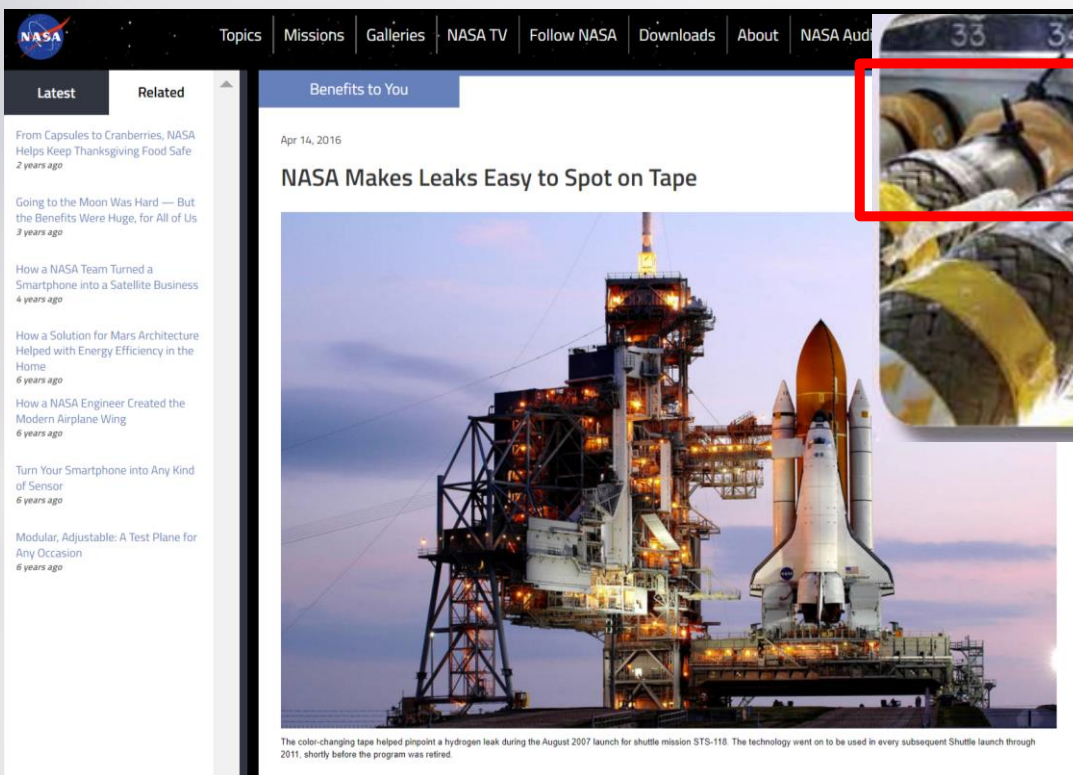
Space Shuttle Endeavor arrives at launch pad 39A on August 9, 2007 in preparation for mission STS-118. A leak developed in the Orbiter Midbody Umbilical Unit, or OMBUU (inset), which loads liquid hydrogen and liquid oxygen into the spacecraft's fuel cells.

A color-changing hydrogen-detection tape, seen in beige, which was developed by Kennedy Space Center and the University of Central Florida in the mid-2000s, was applied to the OMBUU and helped to detect the leak's source. The technology went on to be used for every subsequent Shuttle launch up until STS-134, the program's penultimate mission.

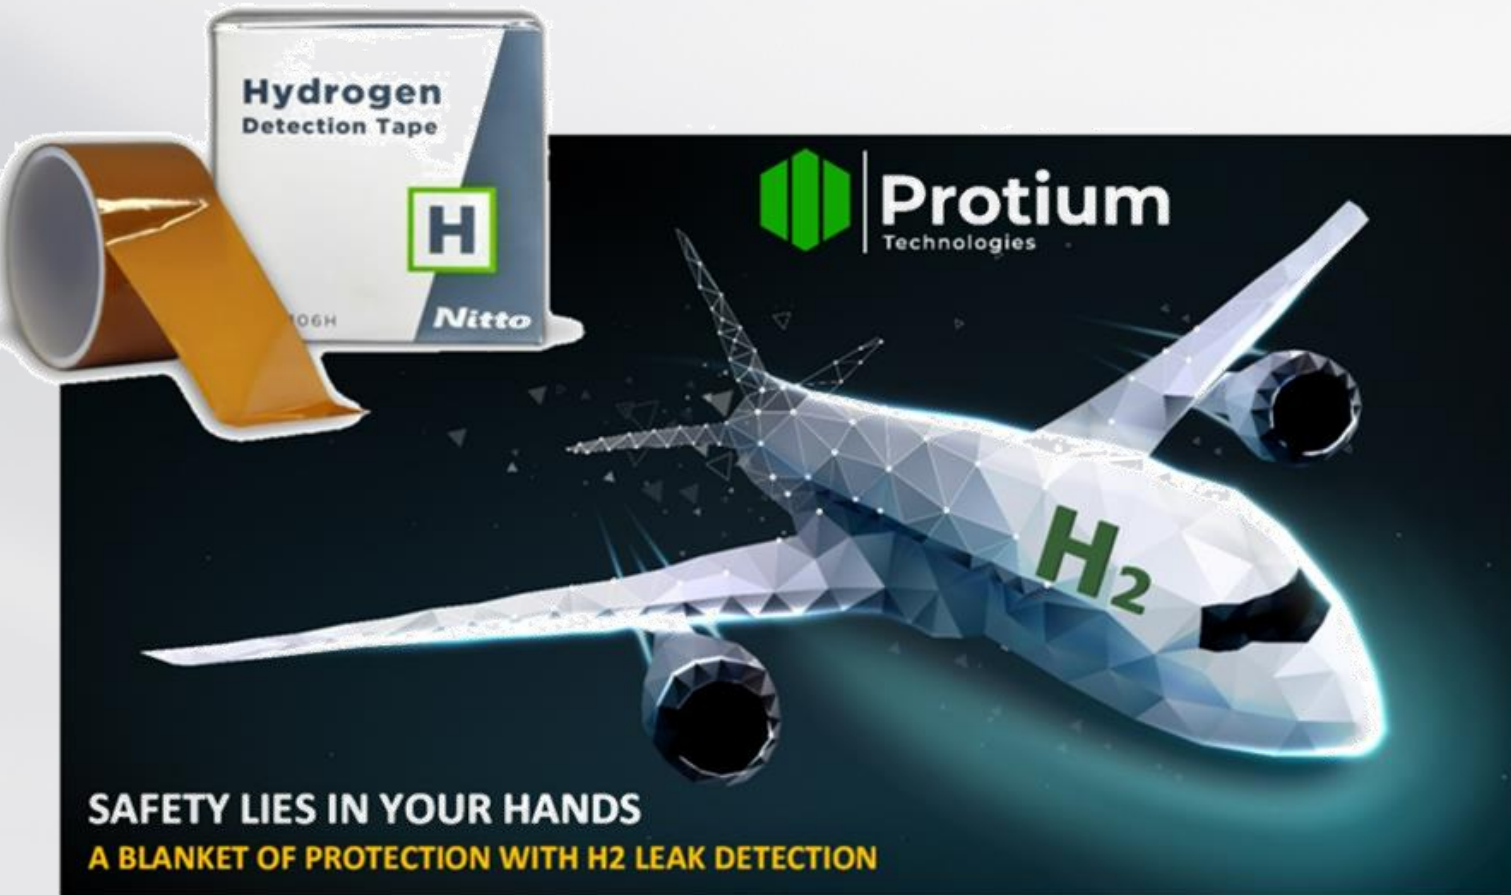
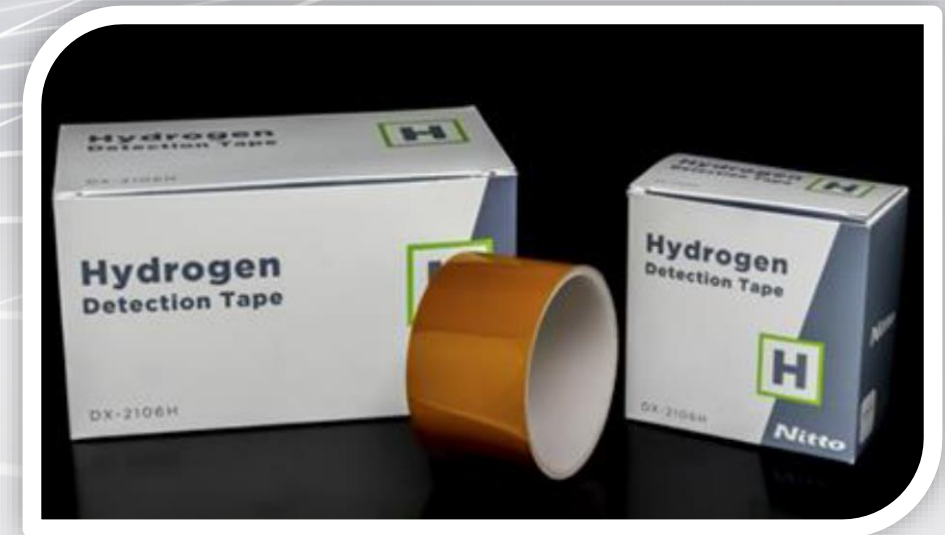
- ✓ Identifies the leak's location with a visible and permanent color change.
- ✓ Proactively detects hydrogen leaks
- ✓ Easy to check vertical and bottom faces
- ✓ Safer to detect leak

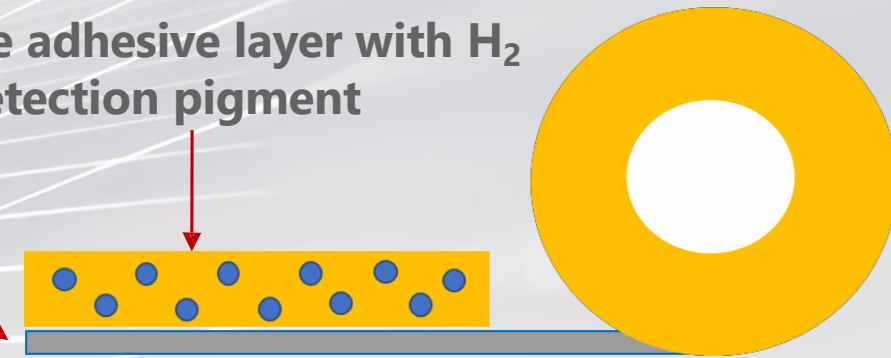
Silicone adhesive layer with H₂ detection pigment

1mil Polyimide backing

Hydrogen Detection Tape will permanently change color, even when the flow of hydrogen gas has stopped.

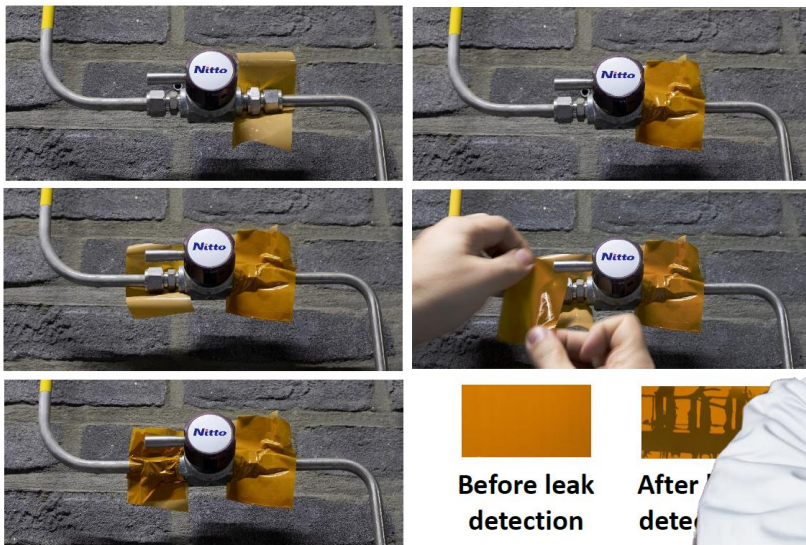
Nitto DX-2106H Hydrogen Detection Tape Butterfly application method

Before leak detection

After detection

- Not every situation will allow for DX-2106H to be easily wrapped around the substrate. In challenging areas, apply DX-2106H using the "Butterfly Wrap" (shown right) method. This not only will help encapsulate the surface, but it also helps with preventing any escape route for hydrogen gas, thereby allowing you to identify a potential leak.

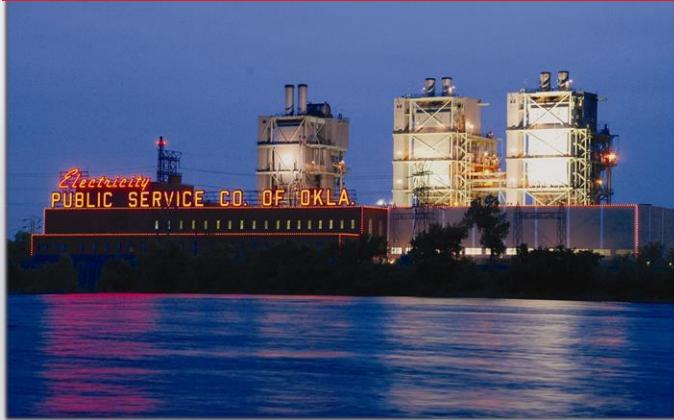
PSO Tulsa Power Station

Objective: Deploy and observe **Nitto DX-2106H Hydrogen Leak Detection Tape** at critical and potential leak locations **for preventative maintenance and continuous monitoring**

Test Period: 90 Days – Active Engagement and Auditing

- Number of Applied Locations: 22
- Number of Applied Tape Areas: 44
- Time to Install: 120 minutes

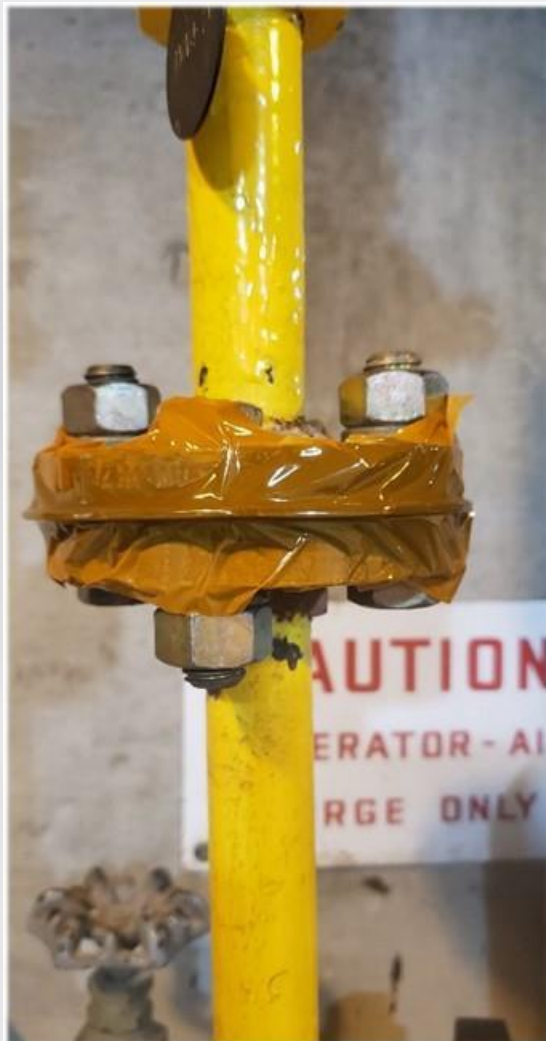
AEP - Location # 2 Hydrogen Purity (Unit 4)

- Location: **UPPER Flange**
 - **Leak Indicated (04/19)**
- Flange tightened and tape reapplied

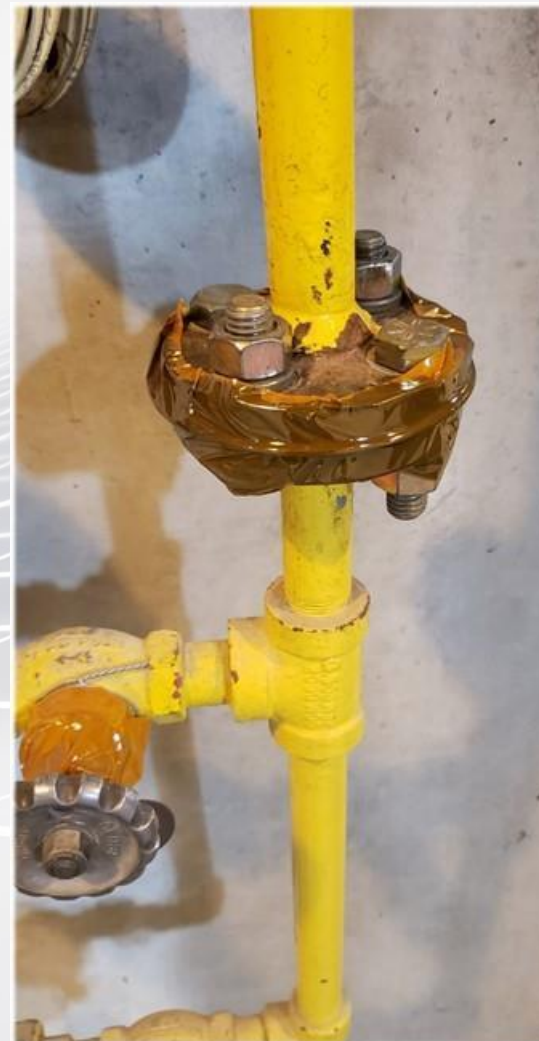
- Location: **LOWER Flange**
 - **Leak Indicated (04/19)**
- Flange tightened and tape reapplied. >> **Leak indicated at audit (04/22)**

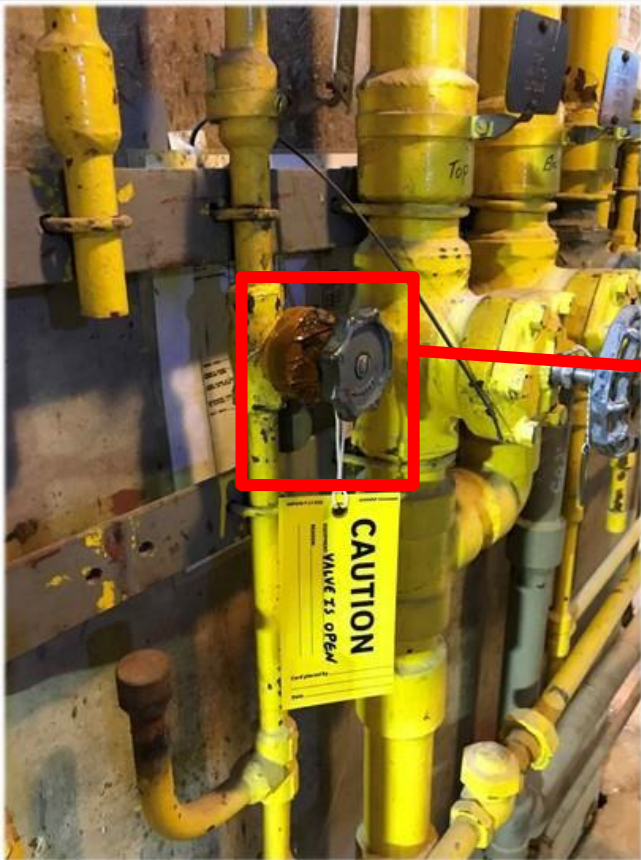
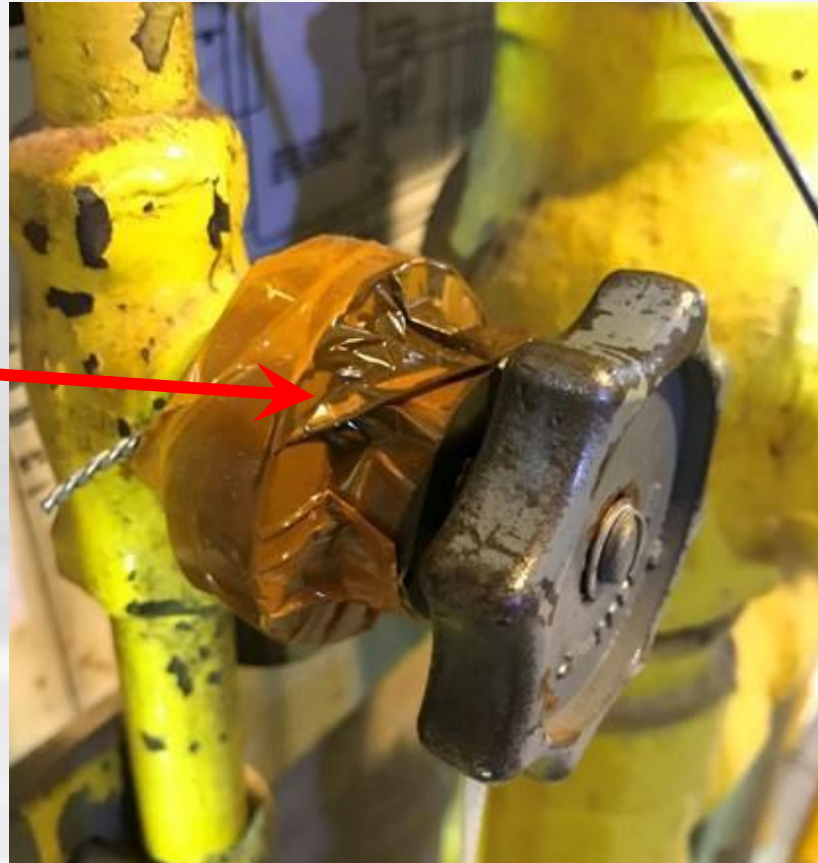
AEP - Location # 3 Hydrogen Distribution Piping (Unit 4)

- Location: Indoor
- **Leak Indicated (06/14)**

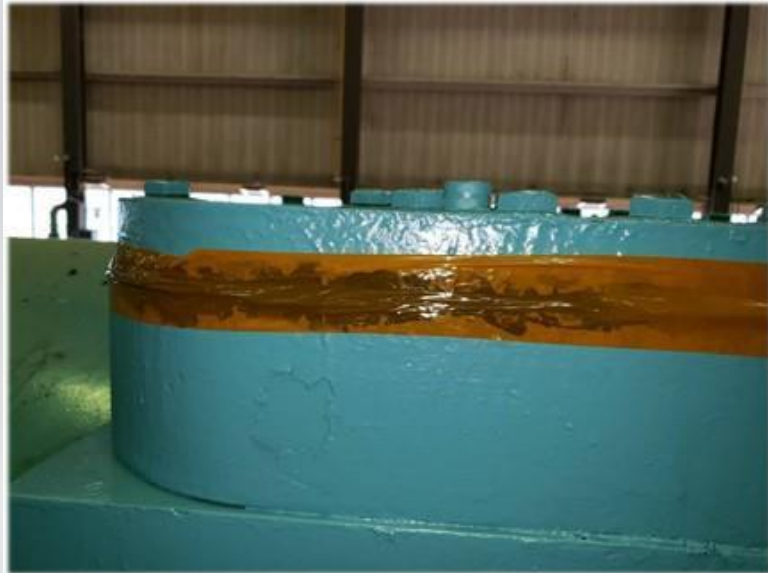
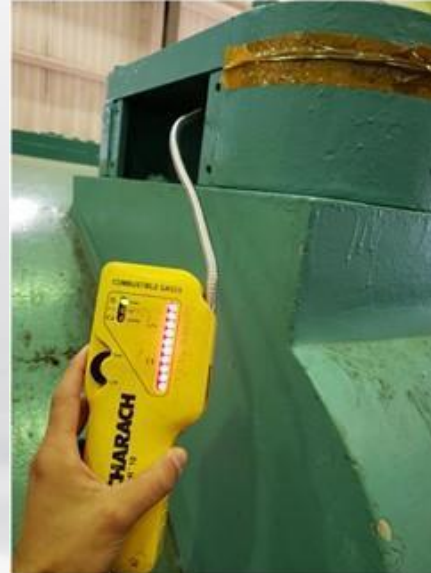
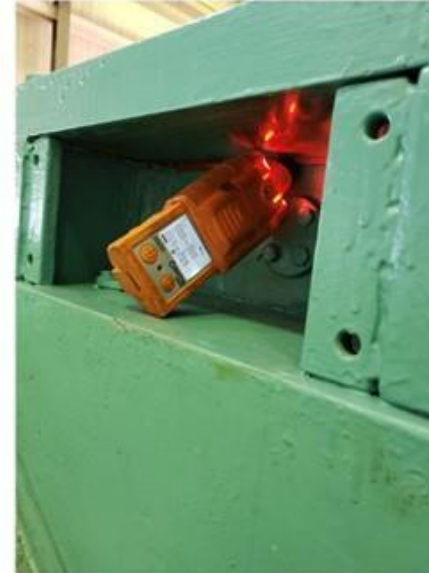
AEP - Location # 9 Unit 1 Hydrogen Cooler

- Location: Indoor
- **Leak Indicated (06/13)**
- Hand held sensors used to verify hydrogen leak

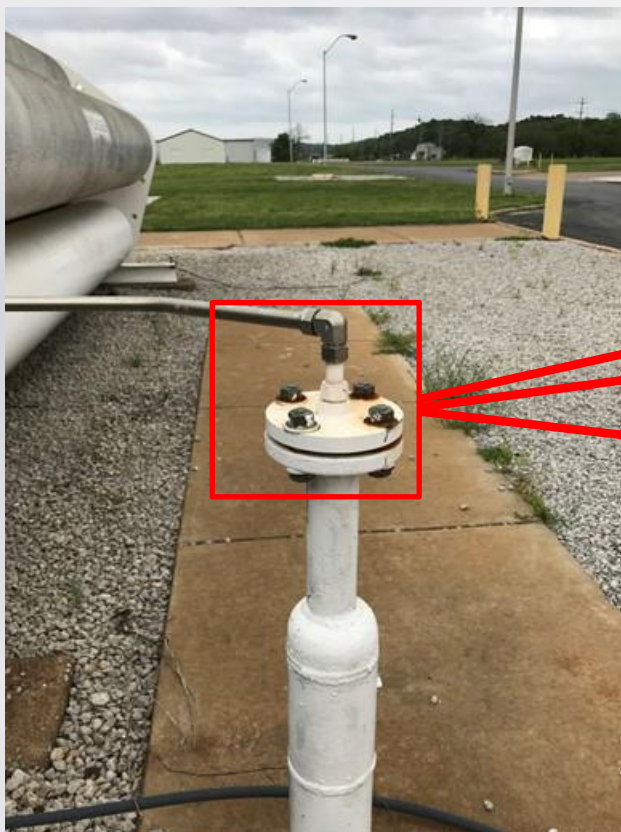
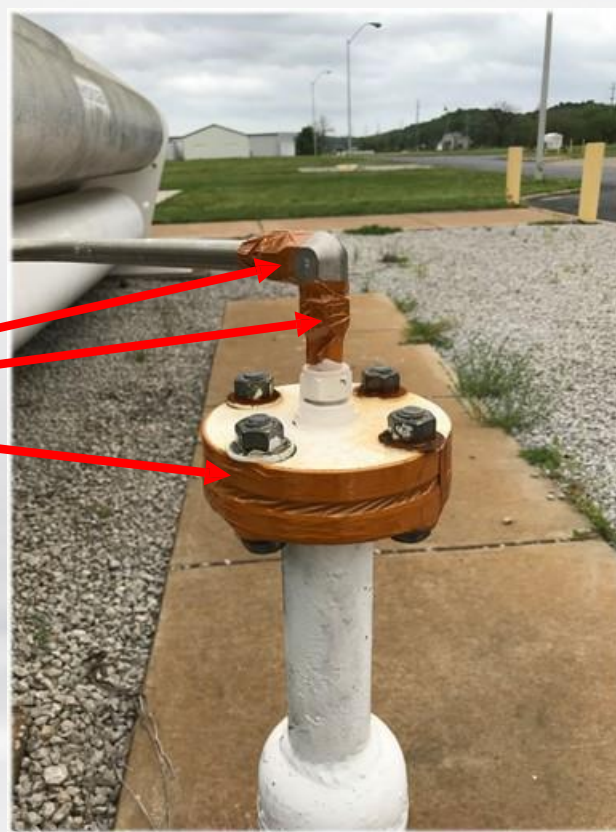
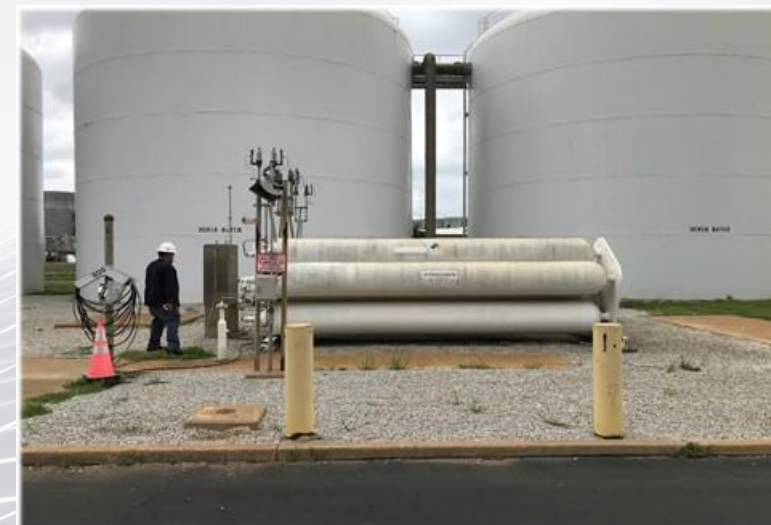
AEP - Location # 16 Flange to Underground Piping

- **Leak indicated on 05/24**
- Flange addressed and tape reapplied
- Leak source mitigated during 06/14 audit
- Pipe Temp: 77.2 Deg. F

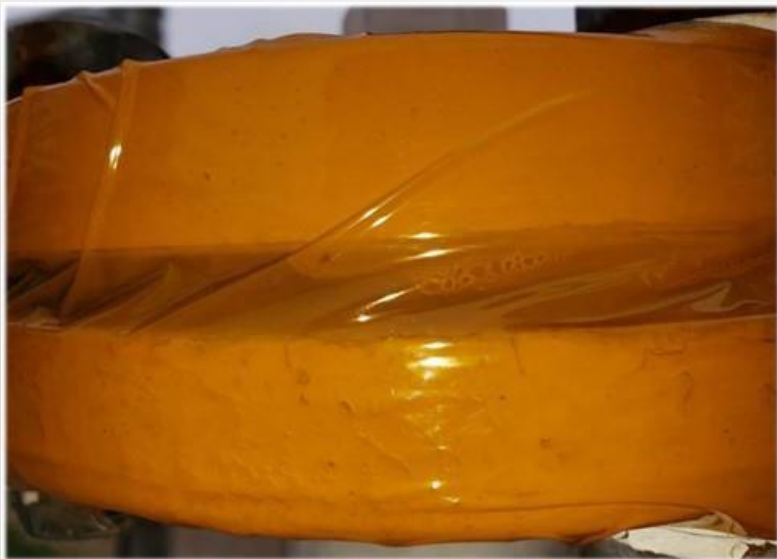
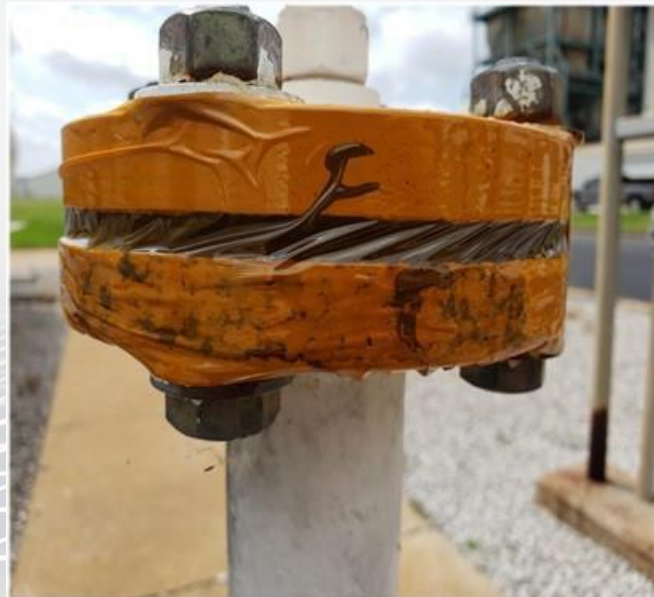
AEP - Location # 16 Flange to Underground Piping

- Date: 05/03
- Moisture bubbles observed following recent **heavy rain storms**

- **Leak Indicated (05/24)**
- Moisture bubbles noticed following recent heavy rain storms (05/03)
- Standing water inside flange (enclosed by tape) – Still effective for H₂ detection

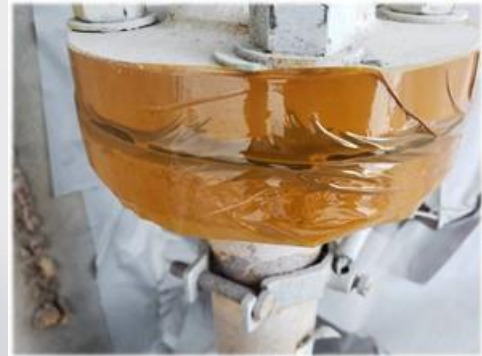
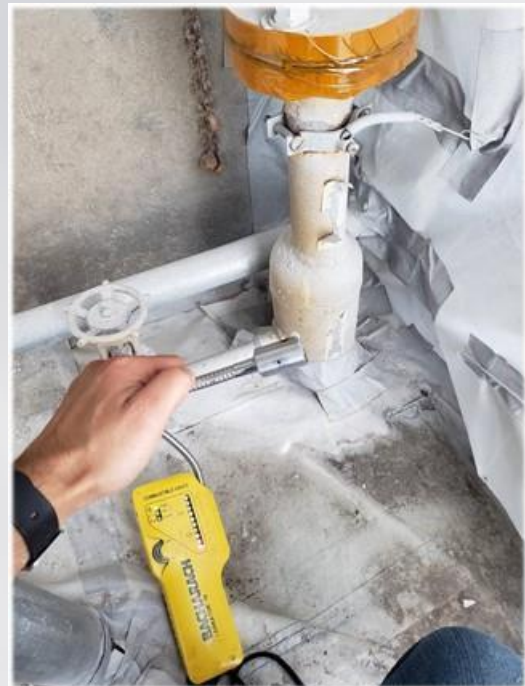
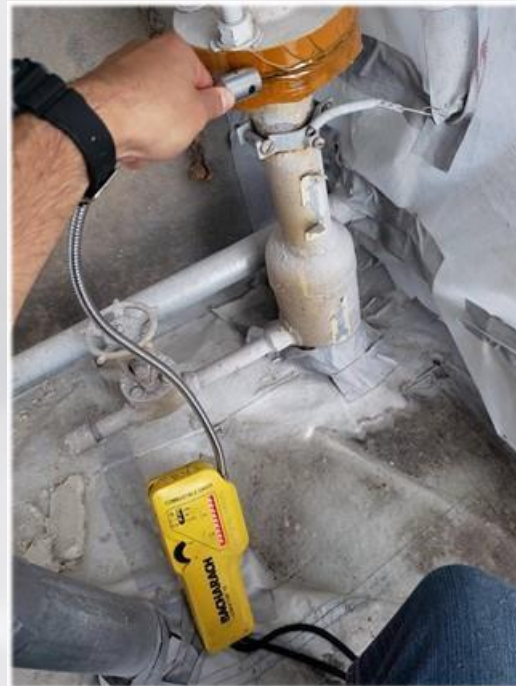
AEP - Location # 18 Flange from Underground to Feed Generator

- **Leak Indicated (05/31)**

- Hand held monitor from distance (12") – No indication
- Made hole in tape and monitored again – **Leak Indicated**

Tape had changed color again. I went around the tape with two different gas detectors and didn't get any alarms. I poked a hole in the tape and checked with both monitors. The yellow monitor is what the operators usually use to look for hydrogen leaks. The monitor didn't alarm when it was a foot or so away from the flange. When I placed the monitor next to the hole I made, it alarmed. When it was away from the flange, there were no alarms. Placed next to the hole I made, it alarmed. **The tape was then removed, and I tried to find a leak with snoop. No bubbles.** Once the testing was completed, new tape was installed.

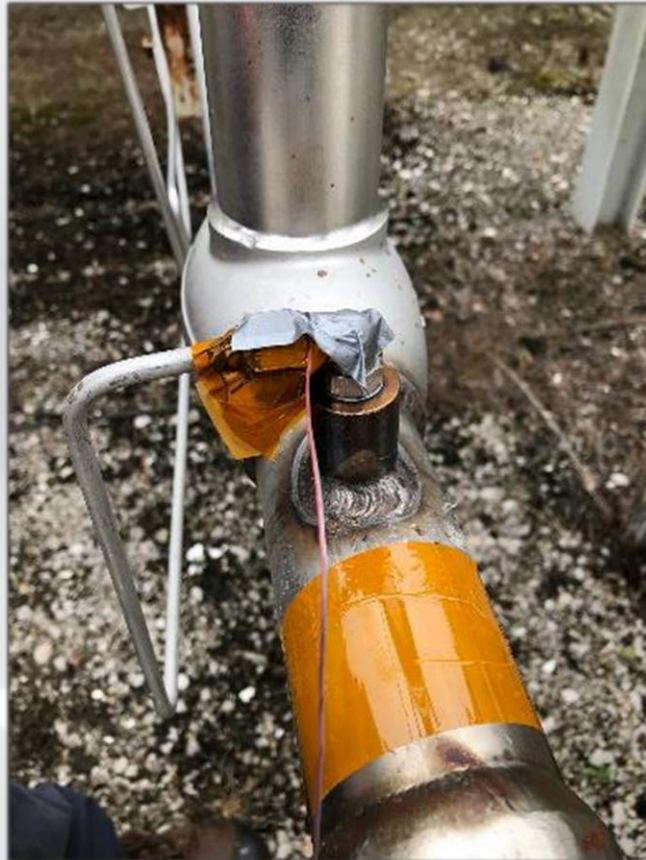
Time: 0 min. / 82 Deg. F (28 °C)

- Location Details: Hydrogen Facility Vent System – The purge connection on vent line. DX-2106H applied directly where no possible leak would occur adjacent to connection. Trailer pressurized to 20 PSIG and vented through line.

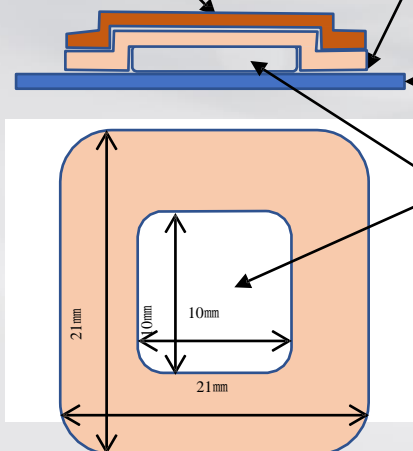
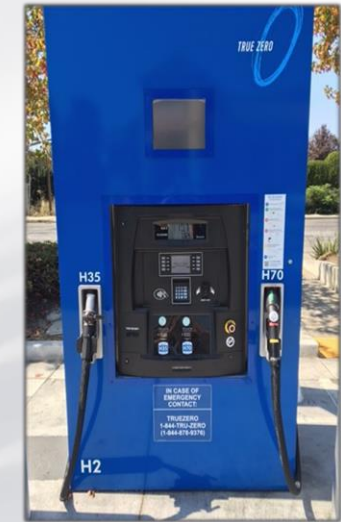
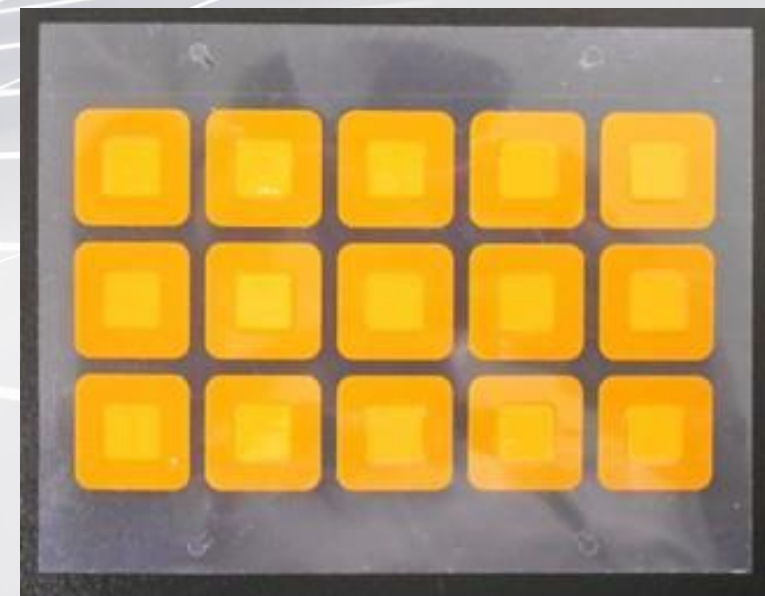
- **Structure**

Polyimide base film

Silicone adhesive layer with H2 detection pigment

Release Liner

Spacer / PTFE porous membrane
